**Iipay Nation of Santa Ysabel
Tribal Water Quality
Environmental Program**

Nonpoint Source (NPS) Assessment and Management Plan

**Prepared by
EcoRenew
San Jose, CA**

June 30, 2024

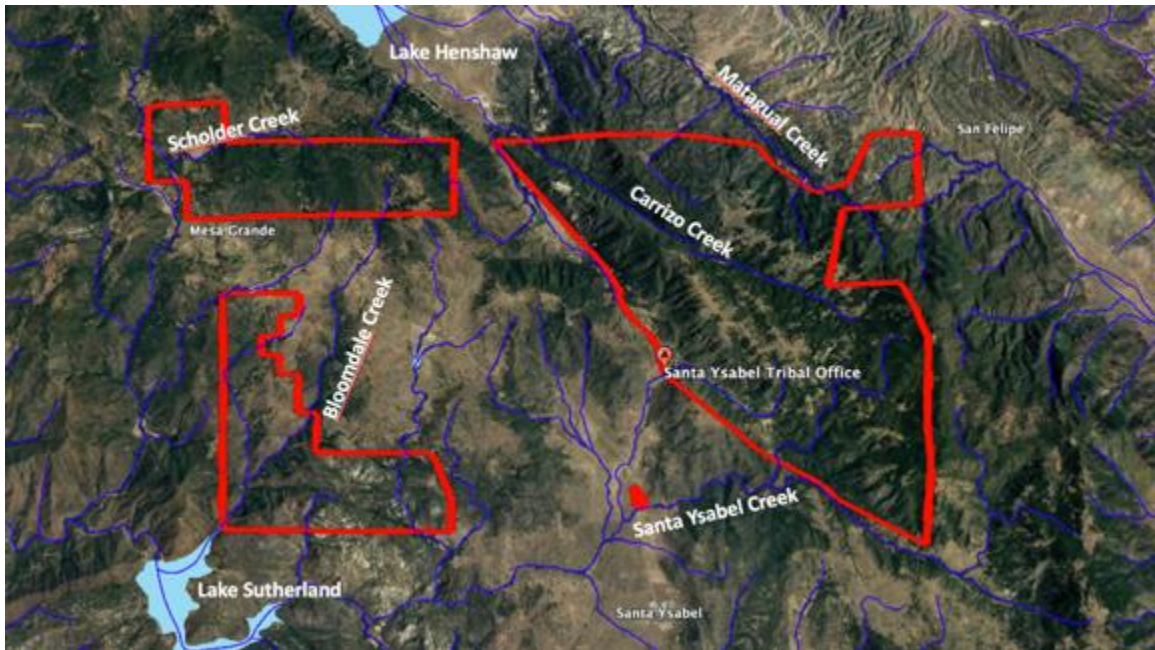
Figure 2. Iipay Nation of Santa Ysabel Reservation land parcels and locations of perennial streams - Santa Ysabel Creek, Carrizo Creek, Matagual Creek, Scholder Creek, Bloomdale Creek and their tributaries.

As seen in Figure 2, INSY Reservation is in the headwaters of the Santa Ysabel Creek. Santa Ysabel Creek, Scholder Creek and Bloomdale Creek flow into Lake Sutherland. Carrizo Creek and Matagual Creek flow into Lake Henshaw. San Felipe Creek flows into the Salton Sea. San Diego County has a Mediterranean climate. The main creeks are perennial and fed by seasonal rainfall and springs during the dry season. These waterways support the INSY Reservation residents' household water needs and agriculture activities, predominantly cattle grazing. Soils of the Traverse and Peninsular ranges typically contain Quaternary alluvium (Calpine coarse sandy loam, Crouch coarse sandy loam, Crouch rocky coarse sandy loam, Holland fine sandy loam, Holland stony fine sandy loam - deep, Holland stony fine sandy loam, Loamy alluvial land, Reiff fine sandy loam, Sheephead rocky fine sandy loam, and Tollhouse rocky coarse sandy loam.

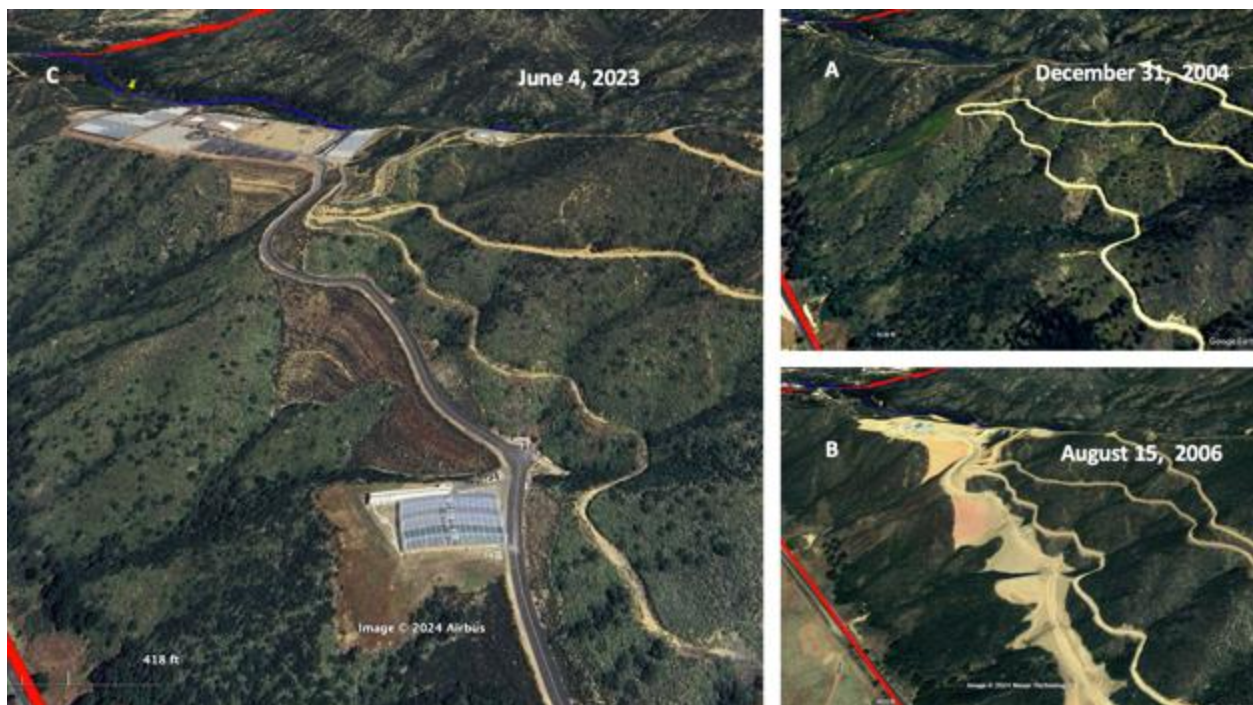
Figure 6. Sediment and water are/are not in balance. Excess sediment is generated at the start of construction in 2004 as part of road development on the hill. In 2006, slope stabilization and cutting of construction pad. In 2023, plants stabilize the hillslope, but the creation of roads and development structures increase water flow from impervious surfaces. A. December 31, 2004, Maxa Technologies; B. August 15, 2006, Maxar Technologies; C. June 23, 2023, Airbus. All images are from Google Earth.

To address nonpoint source impacts from environmental stressors it is essential to understand and manage the drivers of ecosystem function, and recognize their role in water capture, storage and safe release appropriate for the landscape setting. The hydrologic, physical and ecological alterations resulting from terrestrial activity can have a pronounced impact on the natural function of uplands, and stream and wetland riparian areas (Figure 7). Physically, ecosystems are always in motion reacting to natural climatic changes and anthropogenic conditions. These changes in environmental condition will affect the chemical and biological community structure, which cause further alterations to the environment. For example, disturbance within a watershed or adjacent to a stream produces a causal effect, which may temporarily and/or permanently alter one or more attributes and processes (Figures 6 and 7).

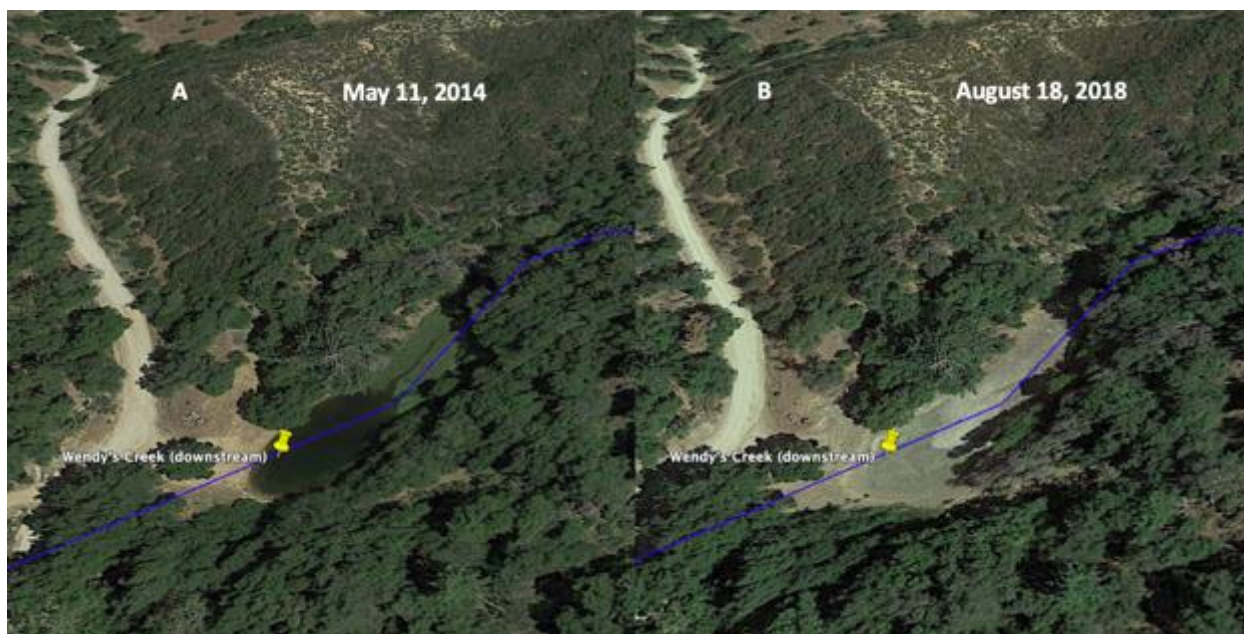
Figure 7. Pond at Wendy's Creek Downstream sampling station. A bend in the stream has a low partial dam, or check dam, to retain water as a cattle watering pond. In May 2014, the pond is present with some floodplain vegetation. Note: Vegetation type cannot be determined from this image. In August, 2018, late season grazing, the pond is dry and the floodplain vegetation is not present. Images were taken by Maxar Technologies, Google Earth.

An examination of Wendy's Creek shows how land management changes affect vegetation and water bodies. As seen Figure 7, a bend in Wendy's Creek has a low partial dam, or check dam, across the stream channel to retain water as a cattle watering pond. In May 2014, the pond is present with some floodplain vegetation (Figure 7A). Note: Vegetation type cannot be determined from this image. In August 2018, the pond is dry, most likely from drought condition, and the floodplain vegetation is not present. As pointed out in Dickard et al., 2015, and Gonzalez and Smith, 2020, if stabilizing vegetation is present (i.e., sedge, rush, cattails) chances are water would be retained in the riparian soils. If annual upland and/or colonizing plants, not having the root mass of stabilizer plants, are present, there is a higher probability water in the soils will not be retained. Some riparian plants (e.g., sedge and willow) are more palatable to livestock than other vegetation. Also, because of the presence of water livestock will hang out/linger longer in the area. As seen in Figure 7B, riparian vegetation has been depleted indicating the stabilizing plant community is absent.
